FIRE INVESTIGATION REPORT

**World Trade Center Explosion and Fire
New York, New York
February 26, 1993**

**Michael S. Isner
Fire Protection Engineer
National Fire Protection Association**

**Thomas J. Klem
Director of Fire Investigations
National Fire Protection Association**

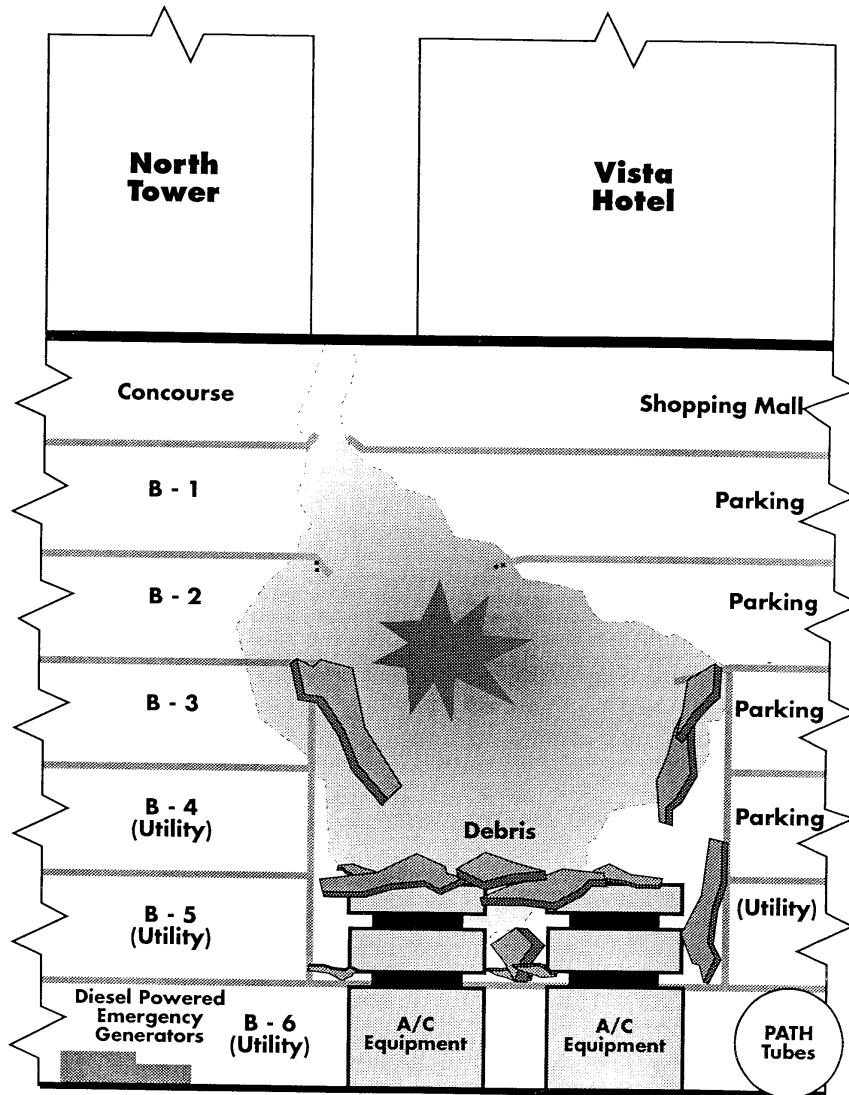
CONCOURSE & BASEMENT LEVELS
Figure 8

The explosion resulted in a large crater involving six levels of the complex. (See Figure 8.) The top-most point of the crater was a 10-ft by 10-ft section of the Plaza floor slab which was cracked and deflected upward. On the next level down, the Concourse level, a plaster-on-metal-lath ceiling collapsed in the Vista Hotel function room, and directly below the collapse, there was an approximately 18-ft by 22-ft hole in the floor slab caused by the explosion below. On the B1 level there was an approximately 50-ft by 80-ft hole where the floor slab had also collapsed. The largest floor slab collapse occurred on the B2 level. On this level, the collapse area was approximately 130 ft by 130 ft. (See Figure 9.) There were no floor slabs at the B3 and B4 levels directly below the explosion area. As a result, debris from the explosion area and the collapsing floor slabs dropped down to the B5 level, where this material landed on the large refrigeration equipment.

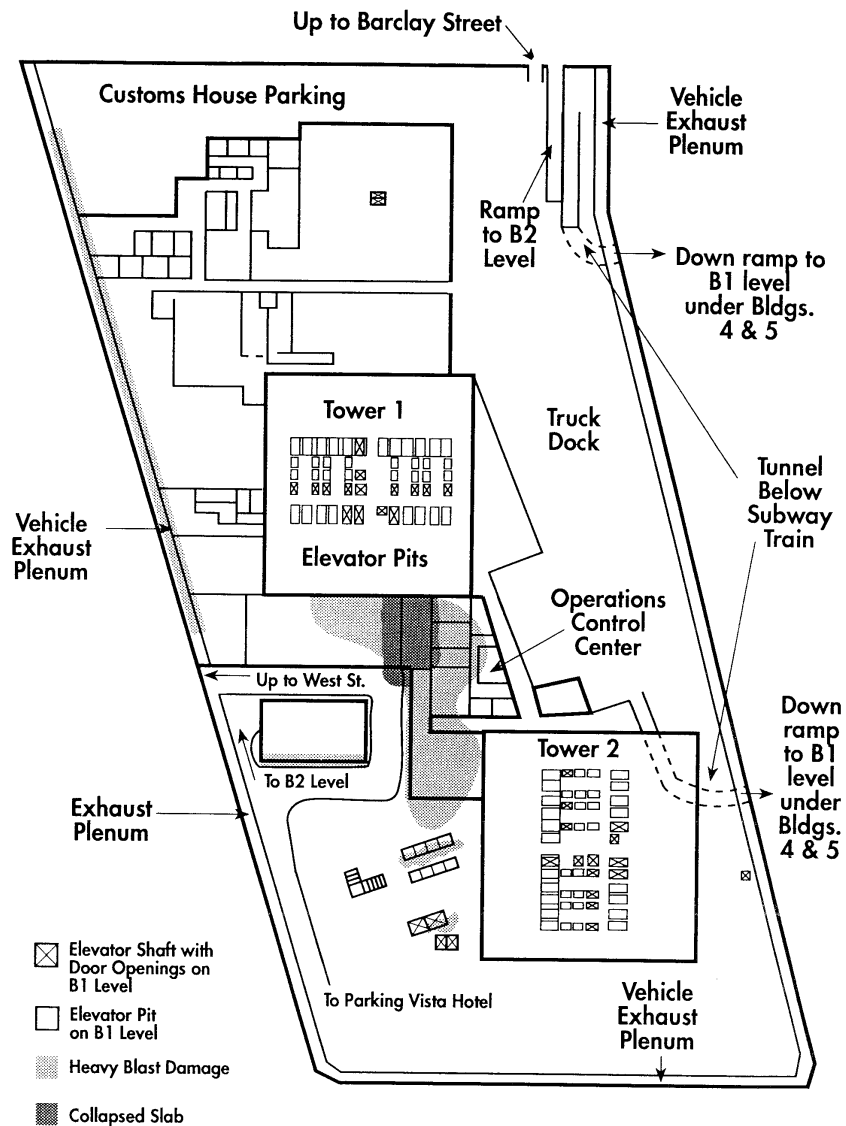
EXPLOSION DAMAGE, B1 LEVEL
Figure 10

The explosion damage also extended to areas well beyond the immediate crater. Concrete block walls on the B1 level were damaged to the point that they needed to be replaced. The damaged walls included numerous nonbearing walls enclosing rooms adjacent to the area of the explosion, and some of the walls formed a vehicle exhaust plenum along the perimeter of that level. (See Figure 10.)

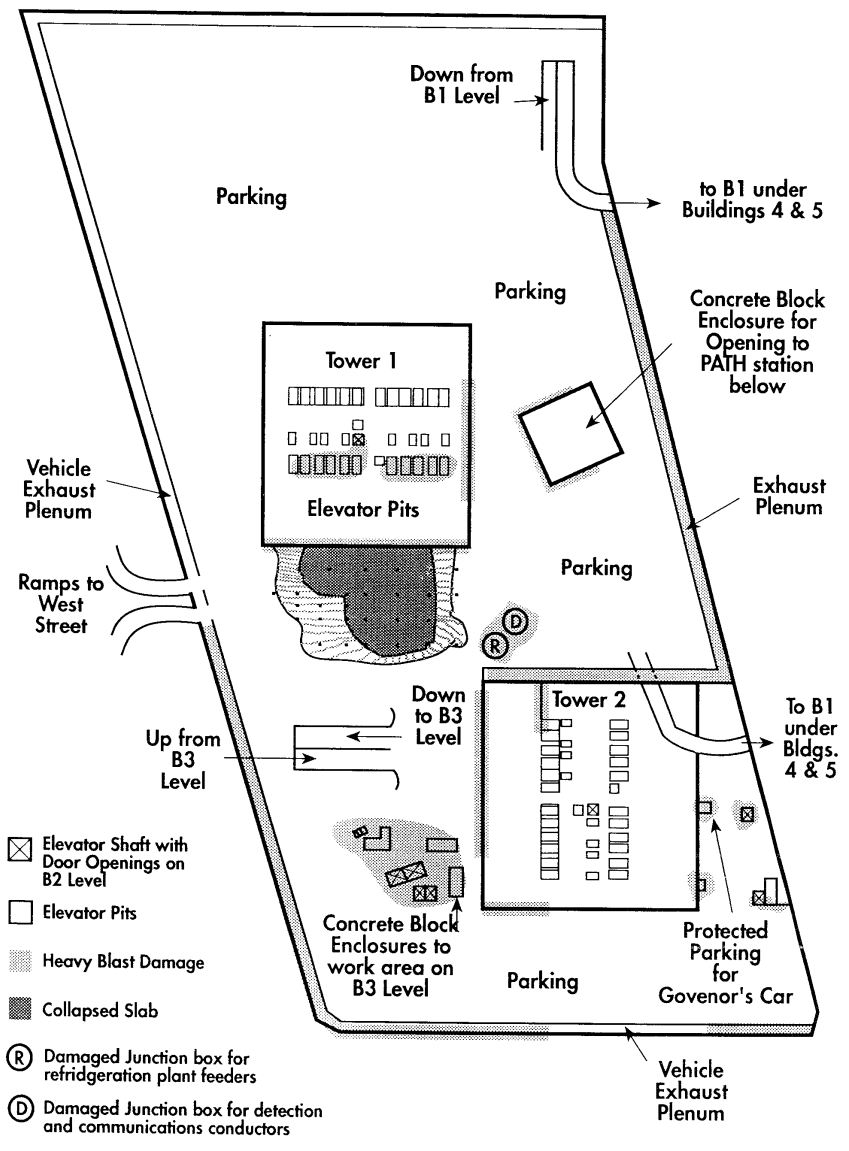
EXPLOSION DAMAGE, B2 LEVEL
Figure 11

Similarly, on the B2 level, many nonbearing walls were damaged or collapsed. (See Figure 11.) The damaged walls included the walls forming the vehicle exhaust plenum along the perimeter of that level, and nonbearing walls enclosing rooms, stairways, and the space above the PATH station were heavily damaged. In addition, the enclosure walls for more than 11 elevator shafts were heavily damaged or collapsed completely. Four of these heavily damaged elevator shafts were for Tower 1 express cars that went to the 44th floor; seven of the shafts were for elevators in the Vista Hotel, and most of these elevators traversed the full height of the building. In addition to the heavily damaged enclosure walls, several enclosure walls for elevator shafts scattered throughout the parking garage sustained a lesser degree of damage, i.e., cracks and/or deflection. These elevators serviced the basement levels terminating at the Concourse level. The damaged walls on the B2 level were located below Towers 1 and 2, the Vista Hotel, and the Customs House, and were up to 550 feet away from the blast area.
