FIRE INVESTIGATION REPORT

**World Trade Center Explosion and Fire
New York, New York
February 26, 1993**

**Michael S. Isner
Fire Protection Engineer
National Fire Protection Association**

**Thomas J. Klem
Director of Fire Investigations
National Fire Protection Association**

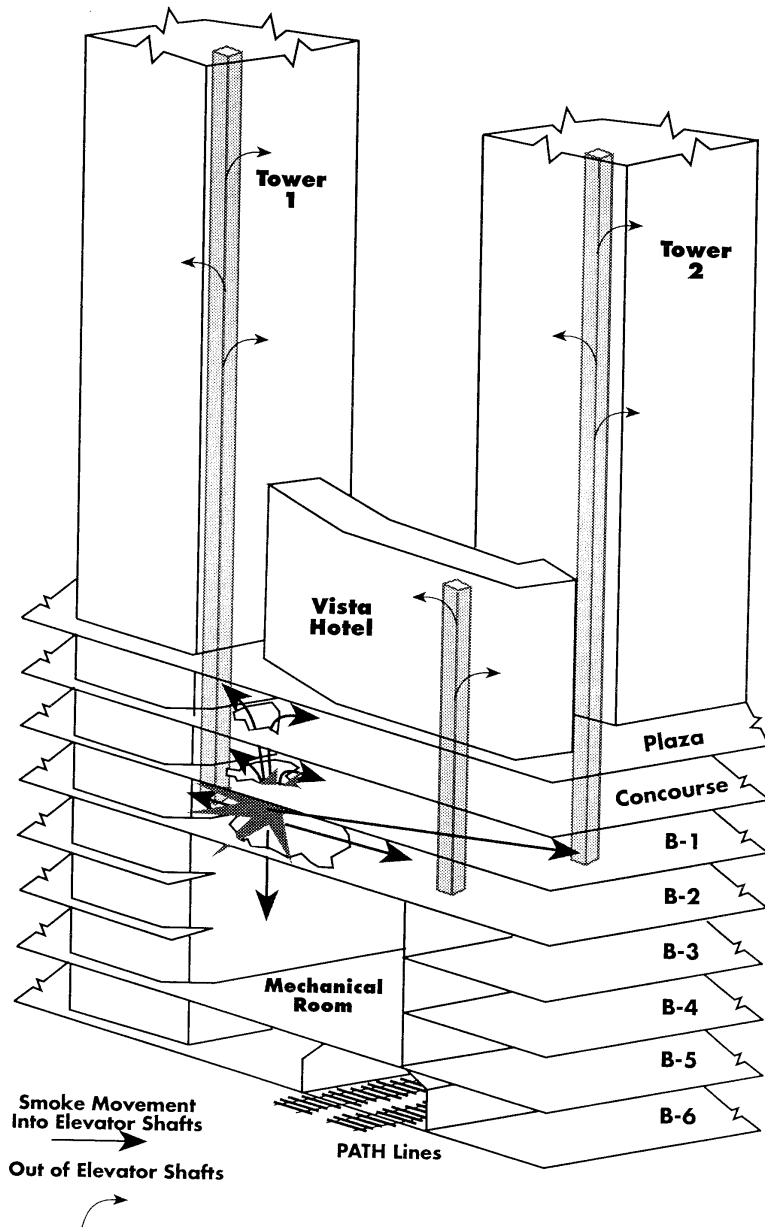
**WORLD TRADE CENTER
Figure 12**

Stack effect forces tended to push smoke into elevator shafts with openings in the lower regions of the buildings. (See Figure 12.) As the smoke moved up the shafts, it eventually began to seep out of the elevator shafts and enter occupied floor levels, even when the elevator doors were closed. The direction of smoke movement, i.e., into or out of elevator shafts, depended on numerous constantly changing variables influencing the stack effect forces. The sky lobbies in the tower provided insight into the complexities of

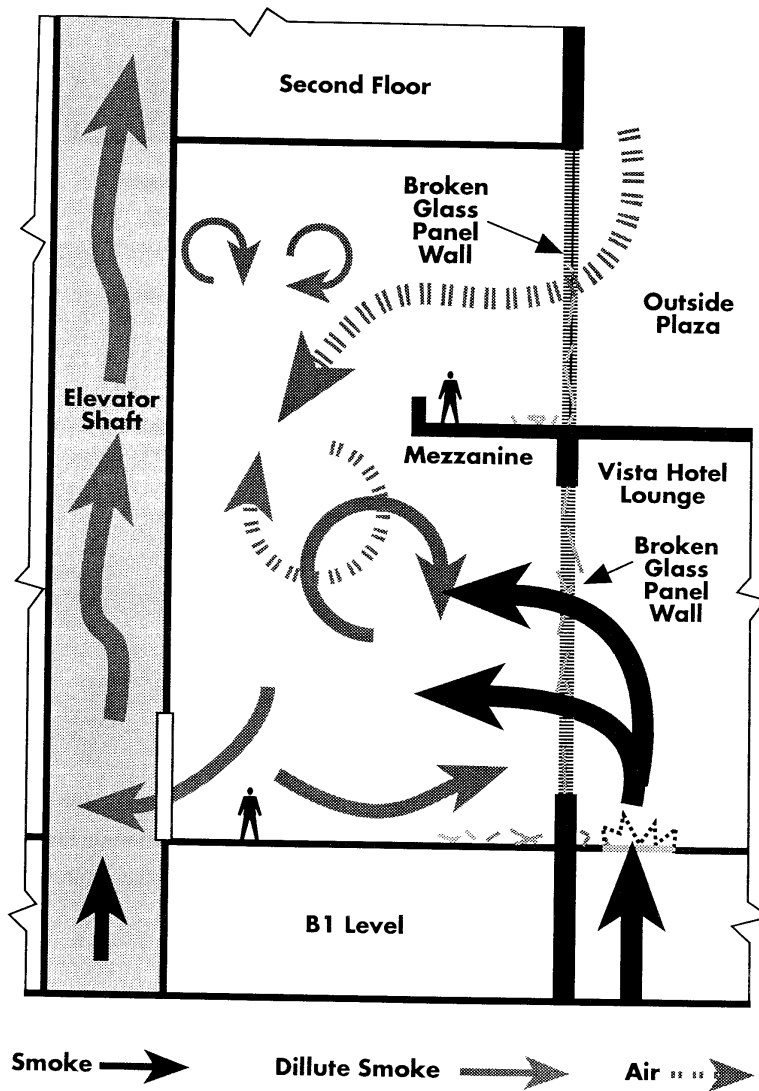
LOBBY: NORTH TOWER
Smoke Dillution and Movement
Figure 13

Investigators believe that the dilution of the smoke was a major factor contributing to the survival of occupants. Even though the fires and explosion seemingly involved a large area of the complex, the area was, in reality, a very small part of the complex's total area. As a result, large quantities of air were available in the facility and were drawn into the smoke even before it spread out of the sub-levels. More air was entrained as the smoke moved up through the buildings. For example, the collapsed section of floor slabs allowed smoke and fire in the sub-levels to spread vertically into the Vista Hotel function room. Smoke from this area spread to other areas of the Vista Hotel and spread through broken windows into the lobby of Tower 1. (See Figure 13.) Outside air entering the lobby through broken glass panel walls in the mezzanine mixed with the smoke and probably pushed smoke accumulating in the lobby down to the floor where it could enter elevator shafts that had doors in that area.
